# TOTAL FIRE GROUP LTD

## Fire Risk Assessment

Montgomery House  
Hawthorne Road  
Oldham  
Greater Manchester  
OL8 3QG

05 August 2026

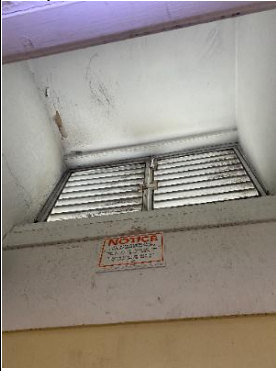
| 8.2 | <p>The permanent vent at the head of the stairs has an insect screen mesh on the inside and remains clear of dust and debris.</p> |

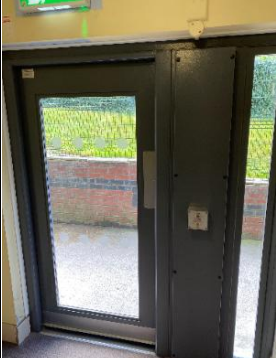
| 8.18-8.22 | <p>The front door is fitted with electromagnetic locks. The door is fitted with a dual push-button release that has been confirmed to release on the loss of power and is configured to release the door in an emergency.</p> <p>The devices are fitted onto the main entrance door, and all residents and their visitors should be familiar with their operation, which is indicated.</p> |

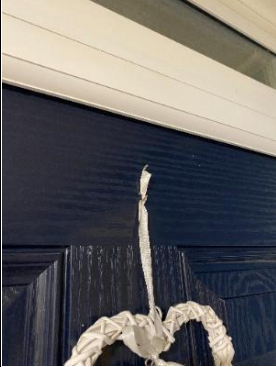
| Ref | FINDINGS |
|---|---|
| 9.1 | <p>It was observed that some flat entrance doors throughout the property had nails fixed to the front face of the doors to accommodate hanging decorations. These nails may affect the integrity of the doors. Where flat entrance doors do not offer a reasonable level of fire resistance, a fire or other products of combustion may be able to spread onto the escape routes, placing persons at risk of harm.</p> |

| Ref | FINDINGS |
|---|---|
| 9.1 | Any nails identified in flat entrance doors for hanging decorations should be removed. Any damage caused by the nails should be adequately repaired, and residents should be advised not to alter flat entrance doors in any way. |

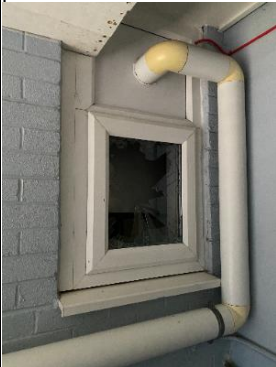
| Ref | FINDINGS |
|---|---|
| 9.1, 9.14 | <p>At the time of the assessment, the bathroom window of flat 39 was smashed. Where glazing units do not offer a reasonable level of fire/smoke resistance, a fire or other products of combustion may be able to spread onto the escape route, placing persons at risk of harm.</p> |

| Ref | FINDINGS |
|---|---|
| 9.1, 9.14 | It is recommended to replace the damaged window unit with a certified 30-minute fire-resisting window unit that is fixed shut, rather than replacing it like-for-like. This would improve the compartmentation between the flats and drying rooms. See 9.1's commentary for further information. |

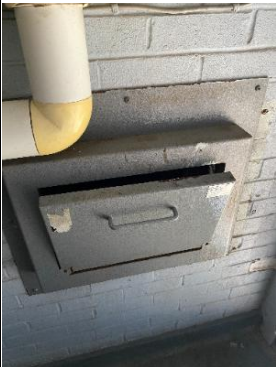
| Ref | FINDINGS |
|---|---|
| 9.17 | <p>The bin chute hopper within the drying room between flats 38 &amp; 41 doesn't close fully, creating a gap within the intended seal. A fire within the bin chute may be able to enter the drying room via the open hopper, placing persons at risk of harm.</p> |

| Ref | FINDINGS |
|---|---|
| 9.17 | The bin chute hopper identified should be repaired by a competent person to ensure the seal is closed fully. |

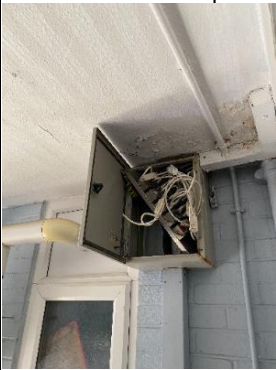
| Ref | RECOMMENDATIONS |
|---|---|
| 9.5 | <p><b>Observation</b></p> <p>The previous fire risk assessment stated that the metal unit in the drying room adjacent to flat 17 was found to be left open. This was confirmed to house TV aerials.</p> <p><b>Note:</b> At the time of this assessment, the unit adjacent to flat 17 was found locked; however, the metal unit adjacent to flat 25 was found to be left open.</p> |

| Ref | RECOMMENDATIONS |
|---|---|
| 9.5 | <p><b>Recommended Actions</b></p> <p>It is recommended that this unit be kept locked shut.</p> |

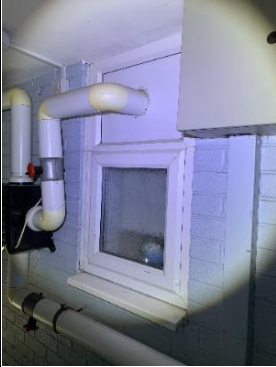
| Ref | COMMENTARY |
|---|---|
| 9.1 | <p><b><u>Extract from previous assessment:</u></b></p> <p>The previous FRA raised an action in relation to the bathroom windows of flats that open up into the drying rooms being mechanically screwed/ fixed shut, as there is a low risk that ambient temperature smoke from a smouldering fire may spread beyond the flat of fire origin via open bathroom/ WC windows to affect a neighbouring flat which may lead to a slight risk of harm to the immediate neighbouring resident/s. This is comparable to smoke spreading externally via an open window and re-entering the building through another open window at a different level. The previous FRA action has not been signed off as complete on Aurora. However, as an alternative to the other recommendations and to totally prevent the risk of any smoke spread via the windows, no matter how small, the windows have been mechanically (screwed/nailed) sealed shut, thus preventing any ambient smoke spread from flat to flat horizontally. The risk of smoke spreading vertically via open windows on the external wall would remain the same.</p> <p>Sprinkler systems are activated by heat from the fire and release water onto it. They are designed to prevent the fire from growing so that much less smoke and heat are produced, and people have more time to escape. In many cases, a sprinkler system will put the fire out. The installation of the residential sprinkler system in the flats/ventilated landing is highly likely to reduce the risk of fire spreading across the ventilated landing. In the unlikely event of fire spreading onto the ventilated landing before the sprinklers become effective, the addition of a heat detector located in the landing provides an early warning of fire for the immediate neighbouring resident/s. The ventilation area has been increased by the removal of sections of acrylic sheeting following previous recommendations, bearing in mind advice from the gas engineer, thus allowing a greater volume of smoke to ventilate to the atmosphere from the landing.</p> <p><b>The risk of harm to relevant persons is assessed as low due to the mitigating measures taken above. However, if future renovation works occur, or window units become damaged, it would be advisable to upgrade the bathroom window units to ones that are fixed shut and provide 30 minutes of fire resistance.</b></p> <p>It is noted that, prior to the installation of sprinklers, a previous serious top-floor flat fire, which likely achieved flashover when the lounge window failed, did not spread to or across the ventilated landing. See 9.11 and 9.16's commentary.</p> |

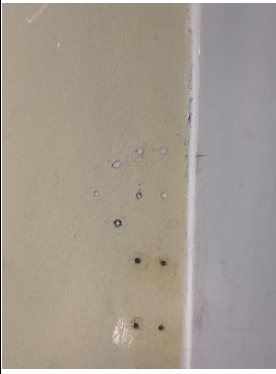
| Ref | COMMENTARY |
|---|---|
| 9.1 | <p>The previous fire risk assessment stated that there were small drill holes next to a number of flat entrance doors.</p> <p><b>Note:</b> At the time of this assessment, the holes previously identified appeared to have been sufficiently filled in.</p> |

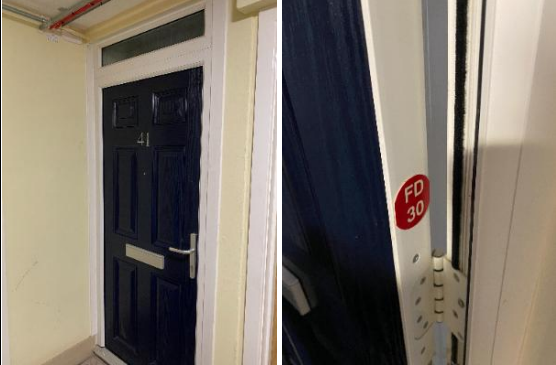
| 9.1, 9.5-9.6 | <p>From the flats accessed at the time of this assessment, the layout is the same as noted in the flats previously accessed. The entrance doors appear to be robust FD30s self-closing composite fire doors, which are a good fit and close fully under the action of the self-closing devices. The person previously consulted advised that the doors are around 7-10 years old, and FCHO has confirmed that these types of doors are only fire tested from one side, and a decision had been made to replace these when they become damaged, which is understood to all have been consulted with the fire service.</p> <p>Test evidence of the performance of the door was available and viewed. A 30-minute fire-resisting doorset report undertaken by Warrington Fire was previously viewed. The conclusions from that report advise that if the NFS 30-minute doorset design, constructed in accordance with the specifications documented in the report, were to be tested in accordance with BS476-22:1987, it is the opinion of Warrington Fire that they would provide a minimum of 30 minutes' fire resistance integrity performance and insulation (subject to section 20 of the report). The report is valid from 10/10/2019 - 10/10/2024, after which a new report would need to be issued.</p> <p>A report from Exova Warrington Fire was also viewed by the previous assessor to show the test evidence of the performance of the doorset, which was dated 15/04/2014 to show that the doorsets had passed the required fire tests.</p> |

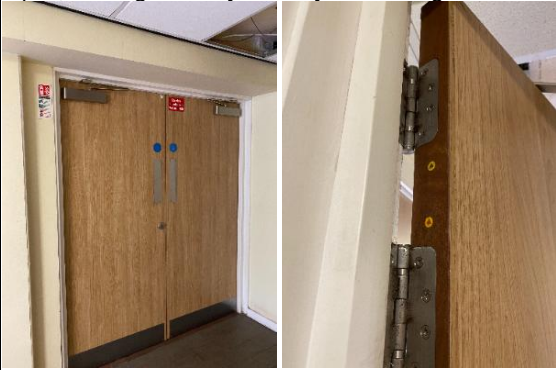
| 9.1, 9.5-9.6 | <p>All doors to the communal areas, including doors to drying rooms, staircase doors, etc., were seen to be in a good state of repair, working correctly and fully self-closing at the time of this FRA.</p> |

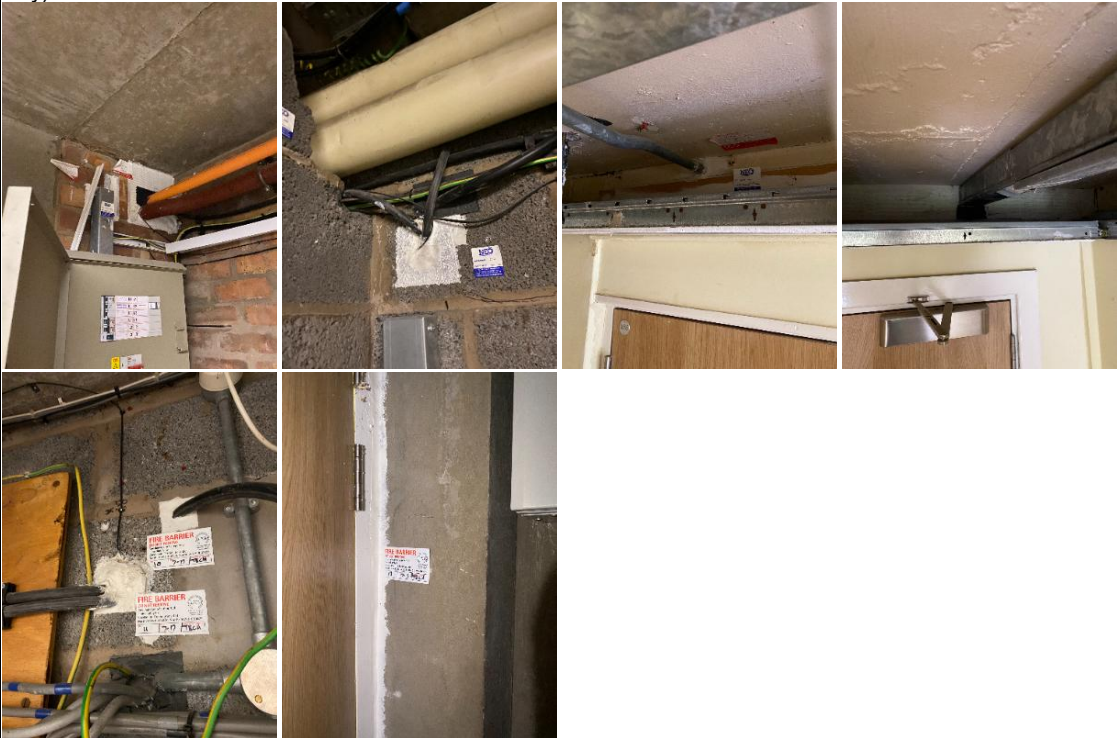
| 9.8 | <p>On-site observations showed that ground-floor plant rooms, ancillary rooms, bin rooms, and other areas were adequately fire-stopped, including areas above the false ceiling on the ground floor and within the trunking and boxed-in sections (sampled only).</p> |

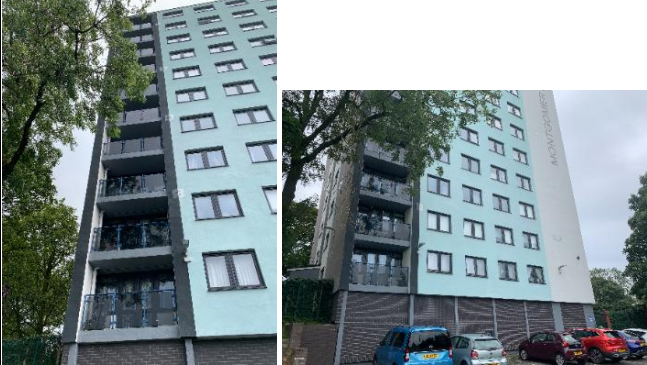
| 9.28-9.29 | <p><b><u>Extract from previous assessment</u></b></p> <p><b>The previous FRA advised:</b></p> <p>The external façade consisting of cement-based rendered EPS insulation has been removed and replaced with a rendered mineral wool insulation without any cavities.</p> <p>Flats are provided with balconies that are part of the original structure and constructed of non-combustible materials. First Choice Homes Oldham displays a document that states not to use or store BBQs, gas cylinders, or anything flammable on the balconies.</p> <p>Some residents may store combustible household items excessively on the balcony which was not observed during the assessment. This forms part of the monthly common area check. The balconies observed were not unduly cluttered with household items with some having outdoor furniture and pot plants.</p> <p>Although not viewed on this assessment, it was previously advised that documentary evidence was obtained by FCHO from the principal contractor confirms that the materials forming part of the external wall conform to European Classification A2-S1 d0 or A1, classified in accordance with BS EN 13501-1:2007+A1:2009.</p> <div data-bbox="236 656 885 1019"> </div> |

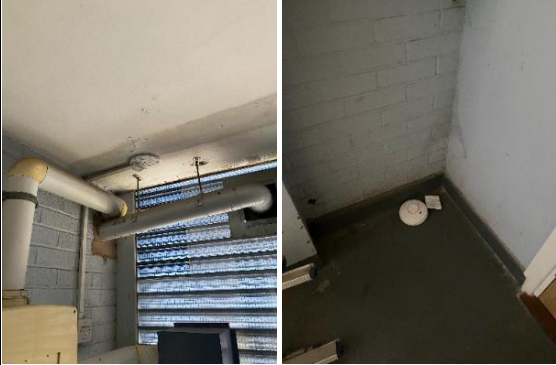
| Ref | FINDINGS |
|---|---|
| 10.7 | <p>It was observed that the detector in the drying room between flats 38 &amp; 41 was removed on flat 38's side. In the absence of suitable automatic detection, there is potential for a fire to spread and develop unnoticed, placing occupants at risk of harm.</p> |

| Ref | FINDINGS |
|---|---|
| 10.7 | The identified detector should be replaced, ensuring full coverage is present within the drying room. |

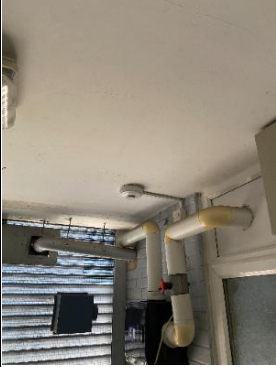
| Ref | COMMENTARY |
|---|---|
| 10.1 | <p>Detection has been installed in all the ventilating landings, bathroom windows have been fixed shut, and the sprinkler system has been fully installed and commissioned. It has also been advised that residents receive regular communications in relation to fire safety.</p> |

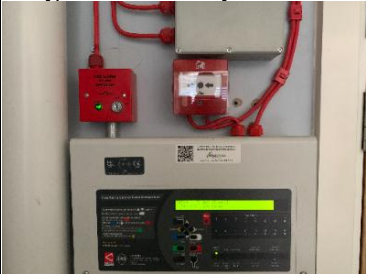
| Ref | COMMENTARY |
|---|---|
| 10.12 | <p>It was previously observed that there is a system installed within the roof area; the fire alarm panel can be accessed on the top floor inside the drying room and appeared healthy at the time of the fire risk assessment, showing no faults. The coverage and the type of fire alarm system can be determined from the commissioning certificate given to FCHO at the time of installation.</p> |

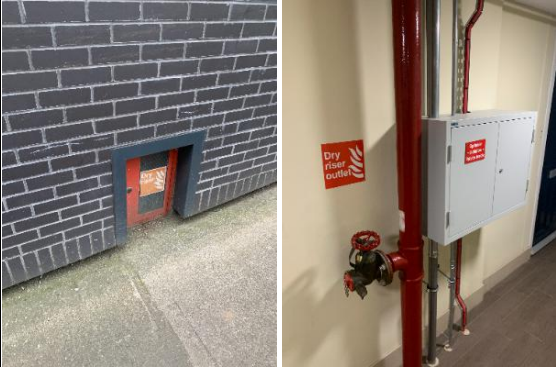
| Ref | COMMENTARY |
|---|---|
| 12.6-12.8, 12.10 | <p>A dry riser is installed with outlets located in the lobby areas to the flats. The landing valve leather securing straps that help to prevent unnecessary water discharge when the riser is charged are correctly located. The dry riser inlet is located by the entrance door to the block. As part of FCHO standard responses, where installed dry risers are subject to 6-monthly checks: full pressure check and visual inspection. Records were not observed at the time of the fire risk assessment.</p> <div data-bbox="236 526 794 891"> </div> |

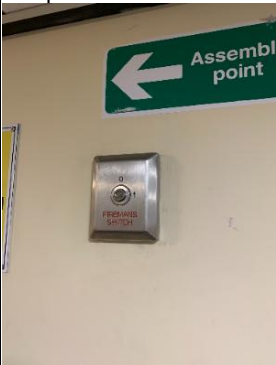
| Ref | COMMENTARY |
|---|---|
| 12.11-12.13 | <p>Lifts with a Fireman's Switch function are provided on the two lifts within the building. Firemen's lifts were installed before fire-fighting lift standards were made available, incorporating only simple means to recall the lift to a designated floor, with no complex lift controls or protection measures for fire and rescue service use, also known as a fire service lift. Where the term "firemen's lift" is used, it refers to a lift installed in accordance with BS 2655-1970 or BS 5655-1986 for use by the fire and rescue service. Firefighters will use a dynamic risk assessment for the use of the lift operationally due to the limited facilities it provides.</p> <p>The person consulted advised that the fire control function is in use and only brings the lifts to the ground floor.</p> <div data-bbox="236 1368 512 1731"> </div> |

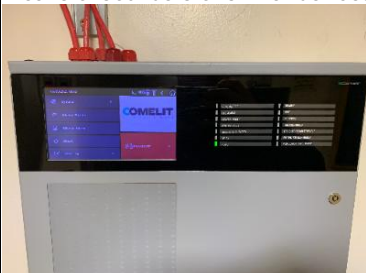
| Ref | COMMENTARY |
|---|---|
| 12.14 | <p>An Evacuation Alert System (EACIE) is installed within the building. The EACIE is equipped with facilities for use by the Fire and Rescue Services (FRS), enabling them to send an evacuation signal to the whole or a selected part of the building by means of sounders or similar devices. Sounders are provided in the hallway of each flat that is linked to this system.</p> <div data-bbox="236 1816 603 2087"> </div> |

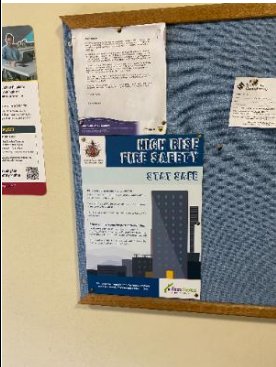
| Ref | FINDINGS |
|---|---|
| 13.6-13.8 | <p>A suitable 'stay safe' fire action notice was provided in the common areas throughout the block to indicate the building's strategy. Although this doesn't incorporate instructions should residents hear the BS8629 Evacuation Alert System, the person consulted advised that, when the system was commissioned, information was given to the residents on what they should do upon hearing the alarm, and FCHO also provided relevant information as part of the annual FRA information and letters as reminders.</p> |

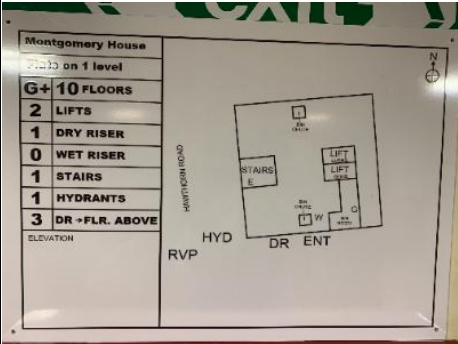
| 14.0 Fire Safety Procedures: Finding(s) | |
|---|---|
| 14.12 | <p>A building information board showing key building facilities is displayed in the lift lobby area on the ground floor. This shows:</p> <ul style="list-style-type: none"> <li>• Number of floors.</li> <li>• Stating the flats are on 1 level.</li> <li>• Number of lifts.</li> <li>• Number of dry risers.</li> <li>• Number of stairs.</li> <li>• Location of nearest fire hydrant.</li> </ul> |
