# TOTAL FIRE GROUP LTD

## Fire Risk Assessment

Montgomery House  
Hawthorne Road  
Oldham  
Greater Manchester  
OL8 3QG

05 August 2025

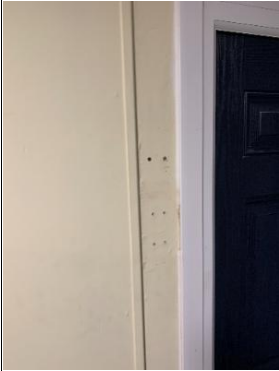
| 9.0 The Confinement of Fire: Finding(s) | |
|---|---|
| 9.1 | <p>It was observed at the time of the fire risk assessment that there were small drill holes next to a number of flat entrance doors. This is more than likely due to a doorbell being installed.</p> |

| 9.0 The Confinement of Fire: Finding(s) | |
|---|---|
| 9.1 | FCHO should monitor these holes throughout the property, and where they are deemed excessive or may lead into the flats, they should be firestopped to the same level of fire resistance as the surrounding wall. |

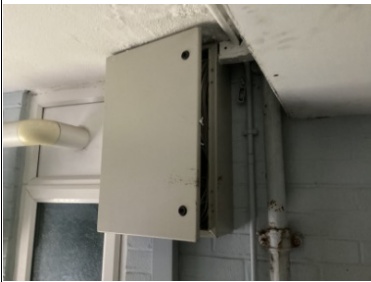
| 9.0 The Confinement of Fire: Finding(s) | |
|---|---|
| 9.5 | <p>The metal unit in the drying room adjacent to flat 17 was found to be left open. This was confirmed to house TV aerials.</p> |

| 9.0 The Confinement of Fire: Finding(s) | |
|---|---|
| 9.5 | It is recommended that this unit be kept locked shut. |

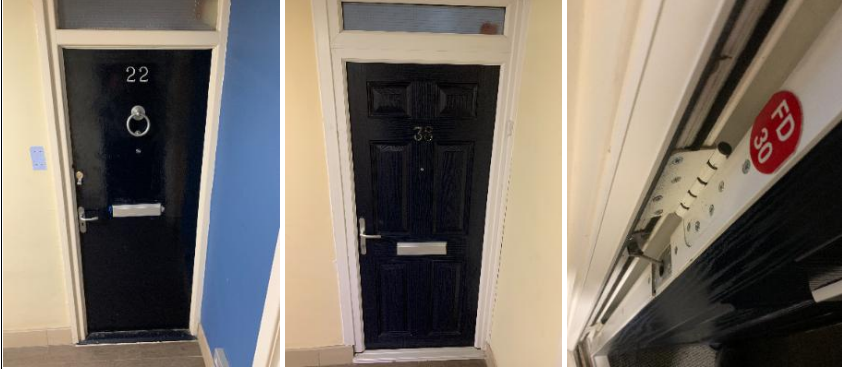
| 9.1, 9.5-9.6 | <p>From the flats accessed, the layout is the same as noted in the flats previously accessed. The entrance doors appear to be robust FD30s self-closing composite fire doors which are a good fit and close fully under the action of the self-closing devices (however, see 9.5's significant finding on a couple not closing/missing self-closers). The person consulted advised that the doors are around 7-10 years old and FCHO has confirmed that these types of doors are only fire tested from one side, and a decision had been made to replace these when they become damaged, which is understood to all have been consulted with the fire service.</p> <p>Test evidence of the performance of the door was available and viewed. A 30 minutes fire resisting doorset report undertaken by Warrington Fire was viewed. The conclusions from that report advise that if the NFS 30 minutes doorset design, constructed in accordance with the specifications documented in the report, were to be tested in accordance with BS476-22:1987, it is the opinion of Warringtonfire that they would provide a minimum of 30 minutes fire resistance integrity performance and insulation (subject to section 20 of the report). The report is valid from 10/10/2019 - 10/10/2024, in which a new report would need to be issued.</p> <p>A report from Exova Warrington fire was also viewed by the previous assessor, to show the test evidence of the performance of the doorset which was dated 15/04/2014 to show that the doorsets had passed the required fire tests.</p> <p>Flat 22's entrance door was different from the rest, however, the person consulted advised that the door is a fire-rated door and was upgraded within the last 2 years with intumescent fire and cold smoke sealed and a self-closing device. (This flat is owned by the tenant.) It was also confirmed that this door is on the list for replacement and has had a new letterbox fitted alongside a new self-closing device.</p> |

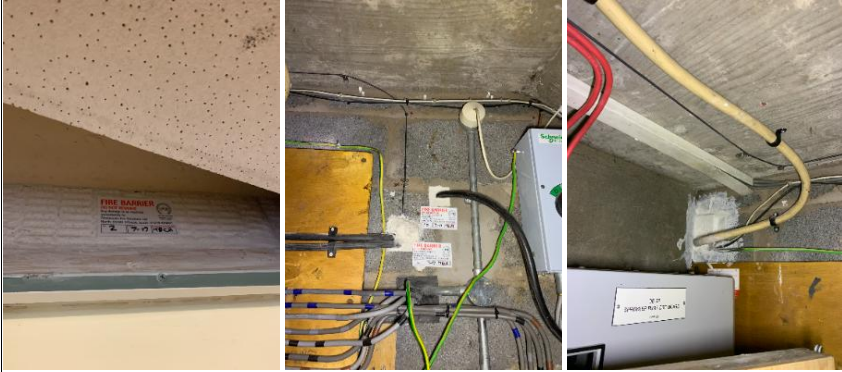
| 9.8 | <p>Onsite observations showed that ground-floor plant rooms, ancillary rooms, bin rooms, and other areas were adequately fire-stopped including areas above the false ceiling on the ground floor and within the trunking and boxed-in sections (sampled only).</p> <div data-bbox="236 633 1082 1003"> </div> |

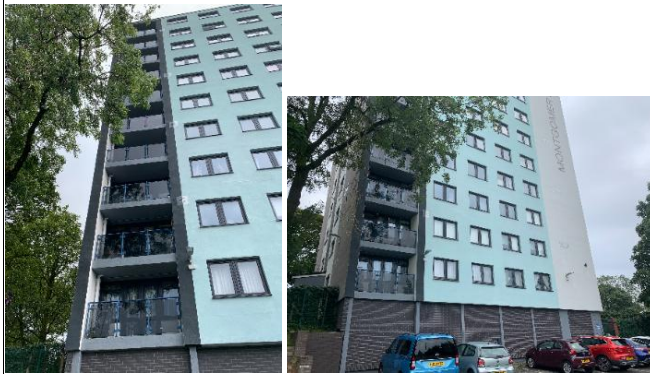
9.27-9.28

The external façade consisting of cement-based rendered EPS insulation has been removed and replaced with a rendered mineral wool insulation without any cavities.

Some residents may store combustible household items excessively on the balcony which was not observed during the assessment. This forms part of the monthly common area check. The balconies observed were not unduly cluttered with household items with some having outdoor furniture and pot plants.

Although not viewed on this assessment, it was previously advised that documentary evidence was obtained by FCHO from the principal contractor confirms that the materials forming part of the external wall conform to European Classification A2-S1 d0 or A1, classified in accordance with BS EN 13501-1:2007+A1:2009.

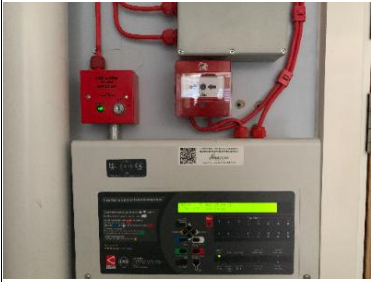
| 10.0 Automatic Fire Detection: Finding(s) | |
|---|---|
| 10.12 | It was observed that there is a system installed within the roof area, the fire alarm panel can be accessed on the top floor inside the drying room and appeared healthy at the time of the fire risk assessment showing no faults. The coverage and the type of fire alarm system can be determined with the commissioning certificate given to FCHO at the time of installation.<br><br> |

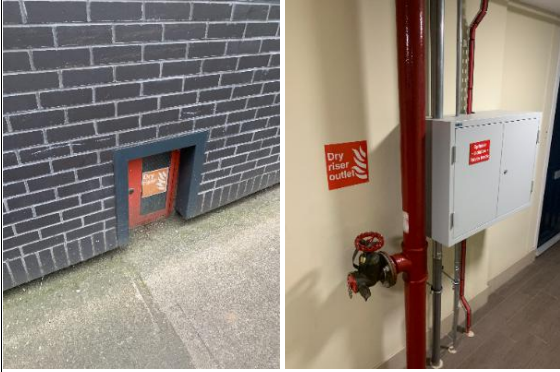
| Ref | COMMENTARY |
|---|---|
| 12.6-12.8, 12.10 | <p>A dry riser is installed with outlets located on the lobby areas to flats. The landing valve leather securing straps that help to prevent unnecessary water discharge when the riser is charged are correctly located. The dry riser inlet is located by the entrance door to the block. As part of FCHO standard responses, where installed dry risers are subject to 6 monthly checks: full pressure check and visual inspection. Records were not observed at the time of the fire risk assessment.</p> <div data-bbox="236 555 798 925"> </div> |

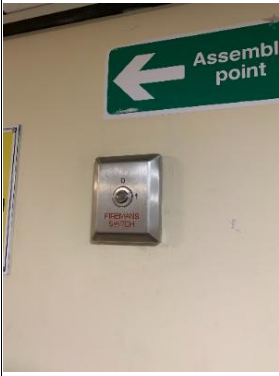
| Ref | COMMENTARY |
|---|---|
| 12.11-12.13 | <p>Lifts with a Fireman's Switch function are provided on the two lifts within the building. Fireman's lifts were installed before fire-fighting lift standards were made available, incorporating only simple means to recall the lift to a designated floor, with no complex lift controls or protection measures for fire and rescue service use, also known as a fire service lift. Where the term "firemen's lift" is used it refers to a lift installed in accordance with BS 2655-1970 or BS 5655-1986 for use by the fire and rescue service. Firefighters will use a dynamic risk assessment on the use of the lift operationally due to the limited facilities it provides.</p> <p>The person consulted advised that the fire control function is in use and only brings the lifts to the ground floor.</p> <div data-bbox="236 1429 515 1803"> </div> |

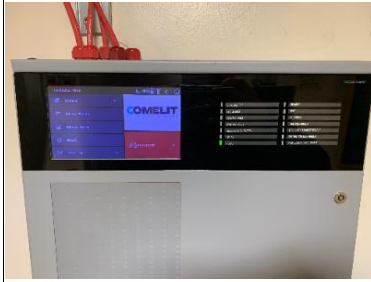
12.14

An Evacuation Alert System (EACIE) is installed within the building. The EACIE is equipped with facilities for use by the Fire and Rescue Services (FRS), enabling them to send an evacuation signal to the whole or a selected part of the building by means of sounders or similar devices. Sounders are provided in the hallway of each flat that is linked to this system.

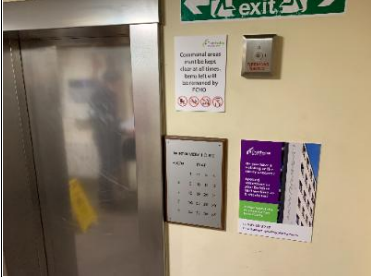
| 13.0 Fire Safety Signs and Notices: Finding(s) | |
|---|---|
| 13.6-13.8 | <p>A suitable 'stay safe' fire action notice was provided in the common areas throughout the block to indicate the strategy of the building. Although this doesn't incorporate instructions should residents hear the BS8629 Evacuation Alert System, the person consulted advised that when the system was commissioned information was given to the residents on what they should do on hearing the alarm, and FCHO also provided relevant information as part of the annual FRA information and letters as reminders.</p> |

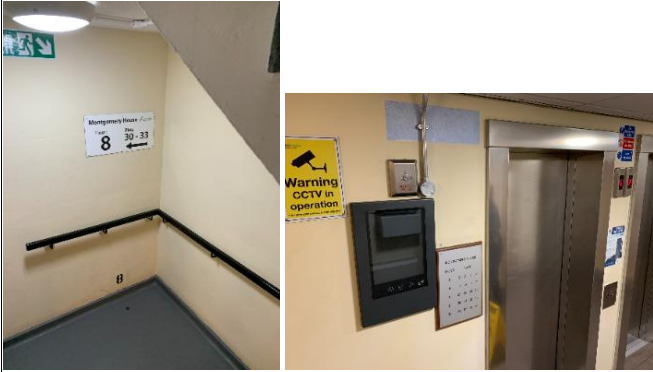
| 13.0 Fire Safety Signs and Notices: Finding(s) | |
|---|---|
| 13.15-13.16 | <p>Floor indication numbers have been painted on the lower part of the wall by the stair door on all floors to aid identification by firefighters when ascending the stairs. This includes the flat/lift lobby areas.</p> <p>Also, wayfinding signage that has the floor number and directional signage to the flats, including flat numbers, is displayed in the staircase enclosure. They appear to be mounted at the recommended height as per ABD and are all visible and in good condition.</p> <p>Supplementary signage is also present, with signage outside the lift area on the ground floor to indicate which floors the two lifts access.</p> |

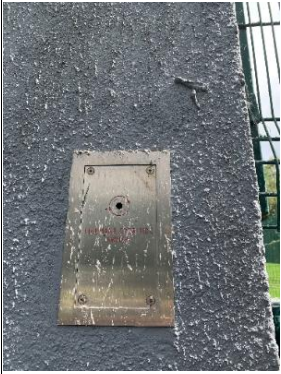
| 14.0 General Fire Safety Procedures: Finding(s) | |
|---|---|
| 14.11 | <p>An override/fire control switch is provided externally above the entrance gate and door to the building for use by the fire service.</p> |

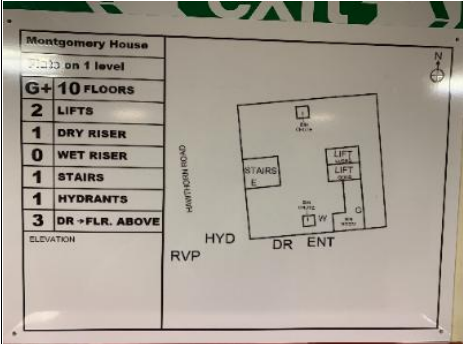
| 14.0 General Fire Safety Procedures: Finding(s) | |
|---|---|
| 14.11 | <p>A building information board showing key building facilities is displayed in the lift lobby area on the ground floor. This shows:</p> <ul style="list-style-type: none"> <li>• Number of floors.</li> <li>• Stating the flats are on 1 level.</li> <li>• Number of lifts.</li> <li>• Number of dry risers.</li> <li>• Number of stairs.</li> <li>• Location of nearest fire hydrant.</li> </ul> |
