# TOTAL FIRE GROUP LTD

## Fire Risk Assessment

1-164 Rountree House  
Manchester Street  
Oldham  
Greater Manchester  
OL9 6HF

04 August 2026

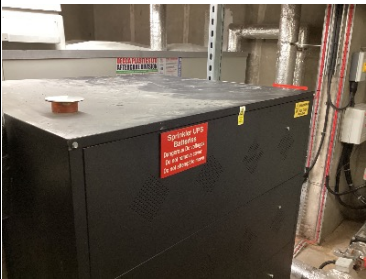
| 6.0 Heating and Electrical Appliances : Finding(s) | |
|---|---|
| 6.26 | A UPS was observed for the sprinkler system.<br> |

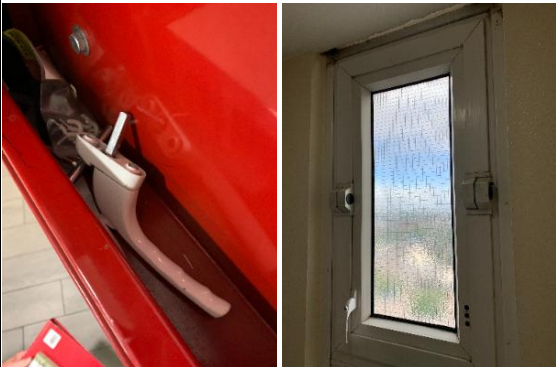
| Ref | COMMENTARY |
|---|---|
| 8.2 | <p>The previous FRA raised an action in relation to staircase windows being locked with handles removed to prevent the windows from easily being opened, and for keys/handles to be provided in the SIB. The previous FRA action has not been signed off as complete on Aurora. However, the person consulted advised that the fire service has been consulted and that a handle has been provided in the SIB for fire service use. This is a generic handle that can be manually added to the window unit to enable all windows to be opened for venting purposes.</p> <p>The permanent smoke vents (PV) in the stair lobby are smaller in area than the minimum recommended. Some smoke may enter the stair and stair lobby as the fire service operations to deal with the fire commence and delivery hoses cause the fire doors to be slightly ajar. Should the stair lobby become smoke-logged during firefighting operations where the PV cannot vent the smoke at the rate at which it is being produced/spreading, the fire service is able to enhance the smoke venting further by the use of the door opening onto the ventilated refuse chute room to assist in evacuation/ rescue where necessary. Should smoke enter the staircase, openable windows can also be used for ventilation by the fire service. Currently, the staircase windows are locked with the handles removed so that they cannot be easily opened. The window handles have been removed to prevent items from being thrown from the windows.</p> <p><b>However; If future renovation works occur, it would be advisable to provide AOVs in the staircase/staircase lobbies between the stairs/lift lobby and the flats with a minimum free area of 1.5 m<sup>2</sup>. In the opinion of our assessor, it is not considered necessary to raise an action for this at this moment in time and instead should be raised following future renovation works.</b></p> <div data-bbox="236 734 794 1099"> </div> |

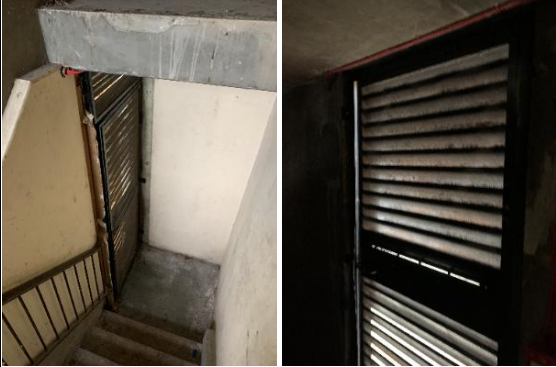
| Ref | COMMENTARY |
|---|---|
| 8.2 | <p>The head of the staircase is fitted with a door that has a louvred vent. In the roof area, there is a permanent vent.</p> <div data-bbox="236 1160 794 1525"> </div> |

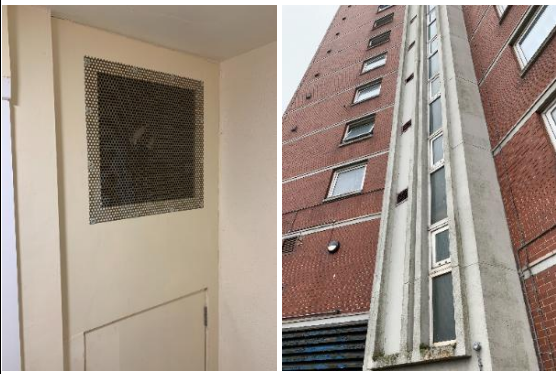
| Ref | COMMENTARY |
|---|---|
| 8.2 | <p>As previously recommended, the void compartment on each floor within the stair lobbies has been opened and a metal protective grille installed to provide a through flow to the externally mounted permanent vent to allow any smoke entering the lobby to vent to outside.</p> <div data-bbox="236 1630 794 2002"> </div> |

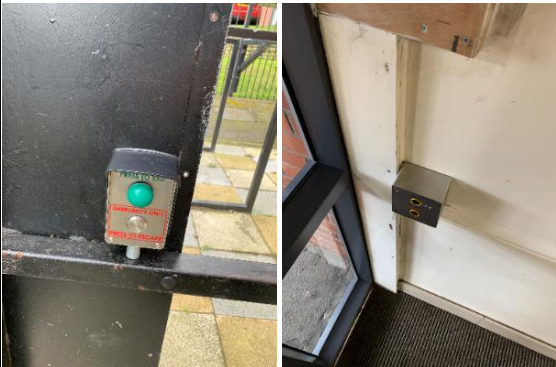
| 8.18 | <p>It was observed that the gate from the basement exit has been fitted with an emergency override. An emergency override was also observed on the ground floor level also.</p> <div data-bbox="236 1444 794 1809"> </div> |

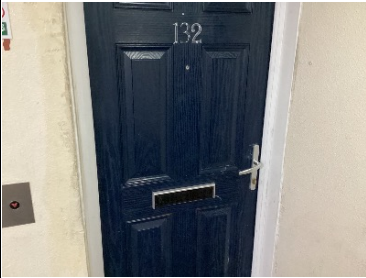
| Ref | FINDINGS |
|---|---|
| 9.1, 9.5 | <p>It was observed that the letterbox cover was missing on the entrance door to flat 132. Where fire doors are missing components, this may allow for the spread of fire and products of combustion, placing persons at risk of harm.</p> |

| Ref | FINDINGS |
|---|---|
| 9.1, 9.5 | It is recommended that the letterbox be replaced. |

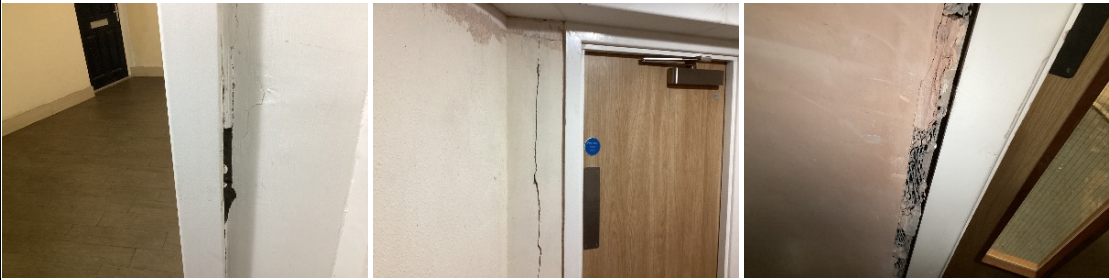
| Ref | FINDINGS |
|---|---|
| 9.1, 9.8 | <p>It was observed at the time of the fire risk assessment that there was damage to the wall next to the door leading to the refuse rooms on the lower ground floor the 14th floor and the basement. Where there is damage to walls around a doorframe, this may allow for the spread of fire or products of combustion, placing persons at risk of harm.</p> <p><b>Note:</b> FCHO are aware of this issue and has confirmed it is due to the ventilation within the refuse room slamming the door.</p> |

| Ref | FINDINGS |
|---|---|
| 9.1, 9.8 | It is recommended that the wall be repaired to the same level of fire resistance as the surrounding structure. |

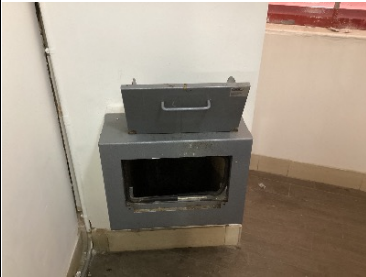
| Ref | FINDINGS |
|---|---|
| 9.17 | <p>It was observed that the bin chutes on the lower ground floor and the 9th floor were defective. Where bin chute hatches are not working correctly this may lead to the build-up of refuse in the communal areas, placing persons at risk of harm.</p> |

| Ref | FINDINGS |
|---|---|
| 9.17 | It is recommended that the bin chute hatches be repaired. |

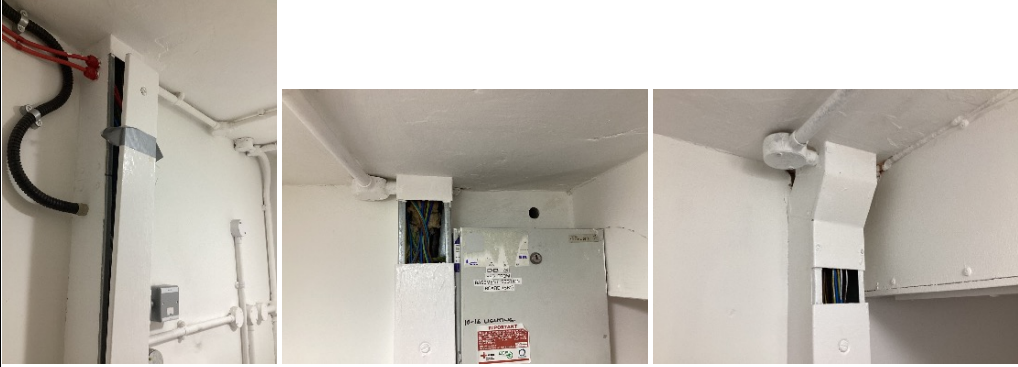
| Ref | RECOMMENDATIONS |
|---|---|
| 9.8 | It was observed at the time of the fire risk assessment that there were open conduits within communal areas on the ground, 1st and 10th floor. There was also a missing cover on the electrical box within the refuse room on the lower ground floor. |

| Ref | RECOMMENDATIONS |
|---|---|
| 9.8 | It is recommended that the conduits be sealed and the electrical box cover be replaced. |

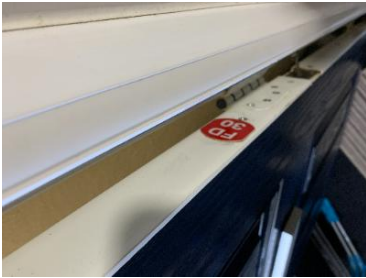
| Ref | COMMENTARY |
|---|---|
| 9.1, 9.5-9.6 | <p>From the flats accessed during the previous fire risk assessment, the layout is the same as noted in the flats previously accessed. The entrance doors appear to be robust FD30s self-closing composite fire doors which are a good fit and close fully under the action of the self-closing devices. The person consulted advised that the doors are around 7-10 years old and FCHO has confirmed that these types of doors are only fire tested from one side, and a decision had been made to replace these when they become damaged, which is understood to all have been consulted with the fire service.</p> <p>Test evidence of the performance of the door was available and viewed. A 30-minute fire-resisting doorsets report undertaken by Warrington Fire was viewed. The conclusions from that report advise that if the NFS 30-minute doorset design, constructed in accordance with the specifications documented in the report, were to be tested in accordance with BS476-22:1987, it is the opinion of Warrington fire that they would provide a minimum of 30 minutes fire resistance integrity performance and insulation (subject to section 20 of the report).</p> <p>A report from Exova Warrington fire was also viewed, to show the test evidence of the performance of the doorset which was dated 15/04/2014 to show that the doorsets had passed the required fire tests.</p> <p>Flat 123's entrance was advised to be a newer door set to FD30s. These are the types of doors that the existing ones will be replaced with should they become damaged.</p> <p>The layout of the flats includes a hallway with bedrooms (a mixture of 1/2 bedrooms), a bathroom, and a lounge leading off at the end of the hallway. The kitchen is accessed off the lounge. The door to the lounge appears to be the original door and with some fitted with spring-loaded or rising butt hinges as would have been fitted at the time of construction. The remaining internal doors are of timber hollow core construction.</p> <div data-bbox="236 943 512 1308"> </div> <div data-bbox="517 1032 884 1308"> </div> |

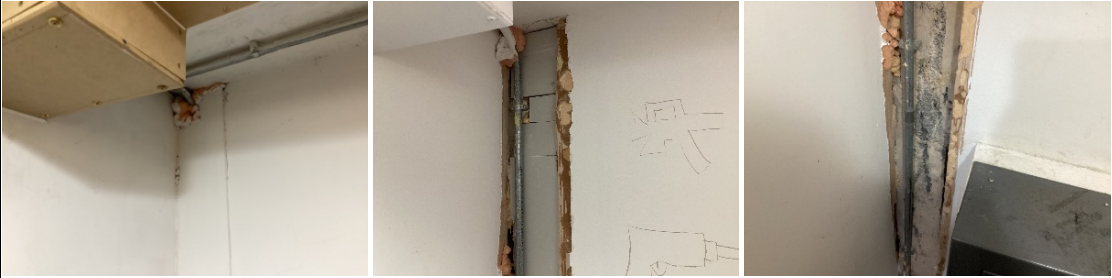
| 9.1, 9.8 | <p><b>For future reference:</b> At the time of the fire risk assessment, it was observed that there was foam filling a breach leading towards flat 104. However, this foam is to cover a hole in the void behind the bin chute and it was seen at the time of the assessment, on a lower floor, that there was a wall to separate the flat and this area. This was seen on the 3rd, 10th and 13th floor also.</p> |

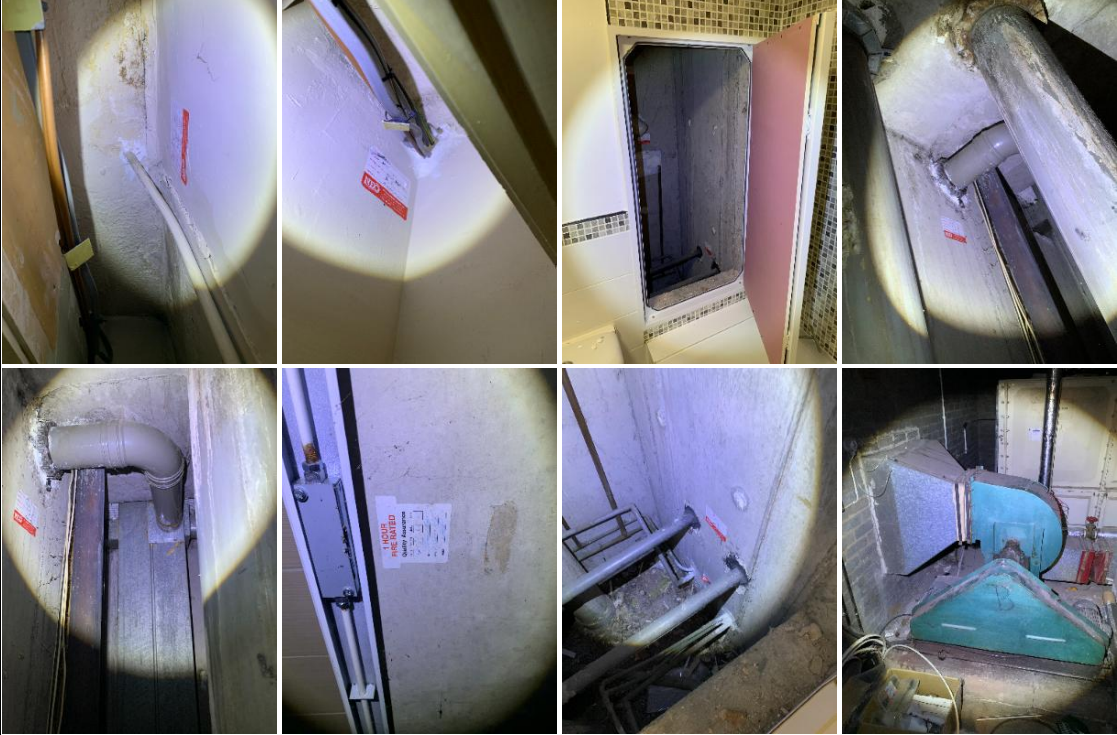
| 9.8, 9.12 | <p>Kitchen ventilation in the previously accessed flats is provided by way of an openable window with a commonly connected vent in the bathroom and WC connected to a common vent duct which has previously been verbally confirmed to be a "Shunt Duct" type configuration. The person consulted on this visit also confirmed this to be correct, and that these shafts and ducts were checked as part of the compartmentation works for the block. The vent from the bathroom into the ducting was found sealed within the shaft along with a pipe collar installed. Roof-mounted extract fans were also viewed and confirmed to provide extraction for the vents. Pipes were observed within a couple of the bathroom cupboards/shafts and the mains electrical supply cable in the electric cupboard has been fire-stopped with contractor labels visible. Photos reused from previous assessment.</p> <p>Examples of completed fire stopping within the flats, and of the "Shunt Duct" type configuration within the bathroom shaft, along with the extraction unit on the roof level.</p> |

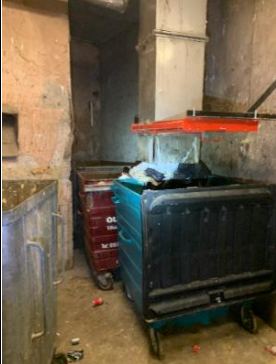
| 9.17 | <p>The refuse chute is protected within the externally accessed bin room by means of a spring-loaded gate, connected to a fusible link. The metal gate slides across the base of the refuse chute to provide fire separation if the temperature from a fire in a bin causes the link to melt. A contractor checks the operation of the spring-loaded gates six monthly. The chute rooms on each landing are checked regularly and are protected by self-closing fire doors.</p> |

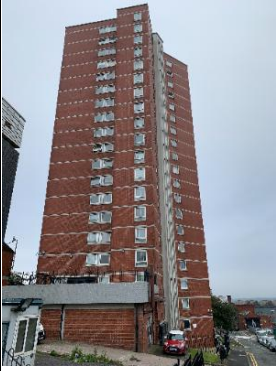
| 9.28 | <p>A non-invasive visual inspection of the external elevations was undertaken from ground level. The external wall construction appears to be predominantly traditional brickwork.</p> <p>No obvious signs of damage or defects were observed during this visual inspection. This FRA has not assessed the construction details of the external wall system, including any associated core/filler/insulation and/or fixing systems, as such matters fall outside the scope of BS 9792 and TFG's insurance limitations. Also see limitations in section 1.</p> |

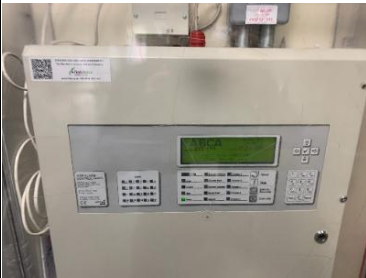
| Ref | FINDINGS |
|---|---|
| 10.1-10.6 | <p>There is a BS5839-1 fire alarm system provided within the common areas, with heat detection extended to flat hallways. The fire alarm panel is located in the lift lobby on the ground floor and was confirmed to be a silent system that is linked to a call centre should the system activate. Provided there is effective compartmentation and means of escape, 'general needs' blocks of flats will not normally require a communal fire alarm.</p> |

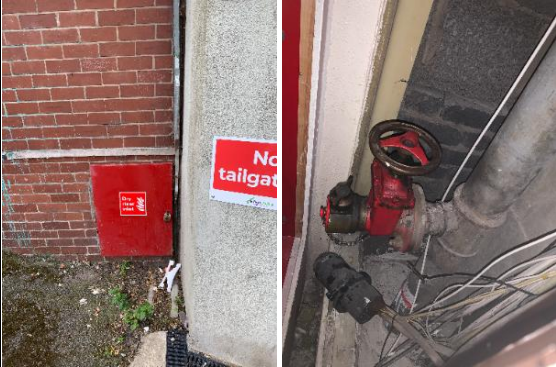
| Ref | COMMENTARY |
|---|---|
| 12.6-12.8, 12.10 | <p>A dry riser is installed with outlets in each ventilated landing lobby. The dry riser inlet is located by the basement entrance door. As part of FCHO standard responses, where installed dry risers are subject to 6 monthly checks: full pressure check and visual inspection.</p> |

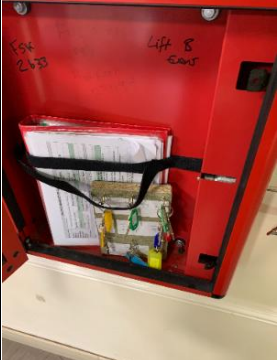
| Ref | COMMENTARY |
|---|---|
| 12.6, 12.15-12.16 | <p>As part of FCHO standard responses, where installed Secure Information Boxes (SIB) are reviewed every 3 months during quarterly building inspections, this includes ensuring information remains relevant, keys and code remain current and vulnerability information is maintained up to date, the approach has been agreed with GMRFS local fire crews.</p> <p>The SIB in the lift/flat lobby area on the ground floor was accessed on this visit to find that it contains information specifically for the fire service, including any information regarding vulnerable residents and floor plans. It is reasonable to assume the fire service carries a key to gain access to the box. It must be noted that the responsibility for updating the information with regard to any vulnerable tenants remains with FCHO.</p> <p><b>Therefore, FCHO should ensure that the information stored in the SIB is kept up-to-date and regularly/reviewed.</b></p> |

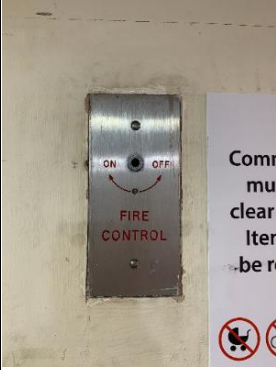
| 12.11-12.13 | <p>Lifts with a Fireman's Switch function are provided on the two lifts within the building. Fireman's lifts were installed before fire-fighting lift standards were made available, incorporating only simple means to recall the lift to a designated floor, with no complex lift controls or protection measures for fire and rescue service use, also known as a fire service lift. Where the term "firemen's lift" is used it refers to a lift installed in accordance with BS 2655-1970 or BS 5655-1986 for use by the fire and rescue service. Firefighters will use a dynamic risk assessment on the use of the lift operationally due to the limited facilities it provides. It was confirmed by Thomas Garret previously that the lift will go to the ground floor and open upon activation of the alarm, from there the fire service is able to control the lift and go floor to floor if needed.</p> |

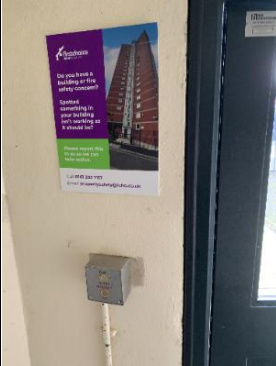
| Ref | FINDINGS |
|---|---|
| 13.6-13.8 | A suitable 'stay safe' fire action notice was provided in the common areas throughout the block to indicate the strategy of the building. Although this doesn't incorporate instructions should residents hear the BS8629 Evacuation Alert System, the person consulted advised that when the system was commissioned information was given to the residents on what they should do on hearing the alarm, and FCHO also provide relevant information as part of the annual FRA information and letters as reminders. |

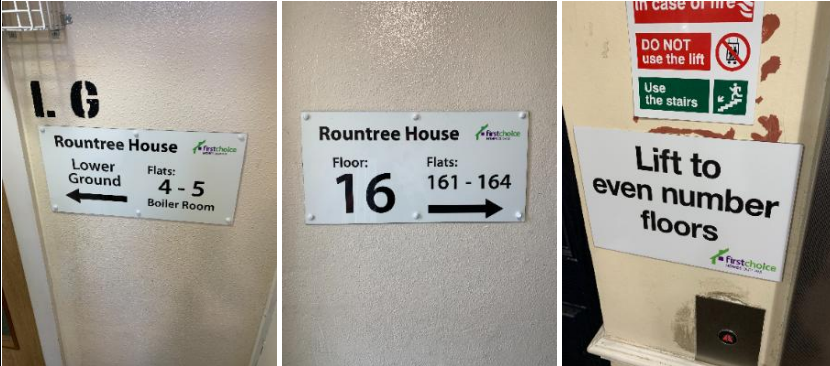
| Ref | FINDINGS |
|---|---|
| 13.15-13.16 | Floor indication numbers have been painted on the lower part of the wall by the stair door on all floors to aid identification by firefighters when ascending the stairs. This includes the flat/lift lobby areas.<br>Also, wayfinding signage that has the floor number and directional signage to the flats, including flat numbers, is displayed in the staircase enclosure. They appear to be mounted at the recommended height as per ABD and are all visible and in good condition.<br>Supplementary signage is also present, with signage outside the lift area on the ground floor to indicate which floors the two lifts access. |
